POLYFLOW

Water Injection Line Rehabilitation in New Mexico

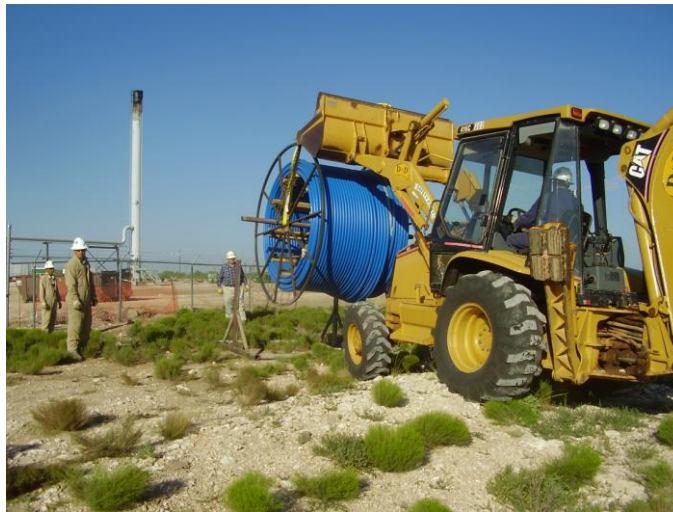
The equipment required for the project was a pigging system, cable to attach to the pig with appropriate pulling force to pull the line, winch to pull back the cable, backhoe to dig out the ends of the line and to handle the Thermoflex spools, tubular A-frame and a coupling machine (supplied by Polyflow) to attach the flange terminations onto the Thermoflex tubing. The tubing is extremely light weight (.48lbs/ft, .32 kg/m) so no special material handling equipment is required. Figure two shows the handling of a 96" spool with a backhoe.

Figure 2: Backhoe setting the spool on the A-frame

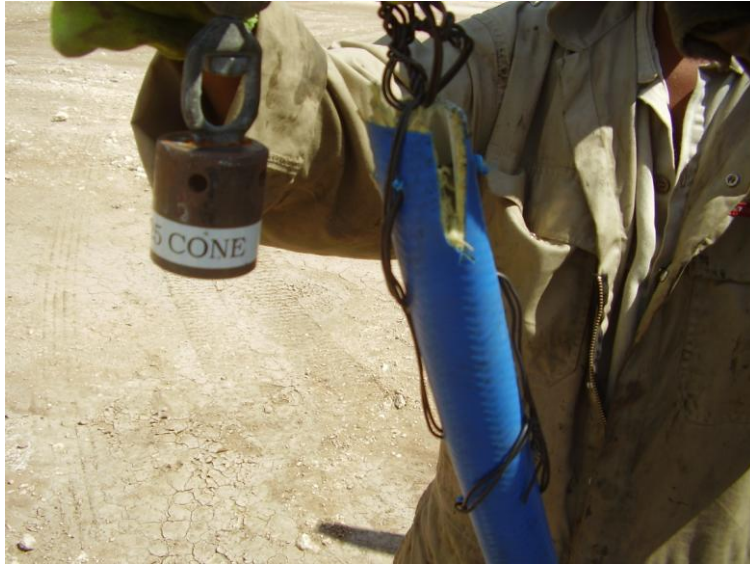
The 1,300ft run was pulled through first. Since the annular space between the existing fiberglass and the new Thermoflex tubing was tight, Polyflow's standard pulling cone would not fit. The end of the Thermoflex had several holes drilled into it and wire was threaded through to serve as the pulling cone. The holes were up to 1 ft from the end of the tubing to make sure that the cables would be pulling with the fibers in the tubing. Figure 3 shows the set up.

Figure 3: Pulling Cable compared with the Pulling Cone

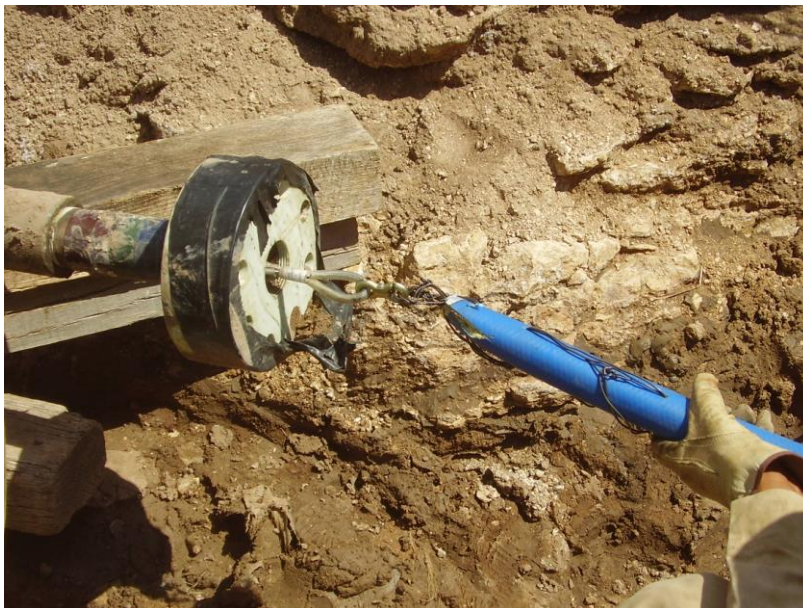
The pipe is hand fed into the existing line to start the pull and then the winch pulls the pipe through the line. There should be at least twenty feet from the entrance of the existing line to the un-spooler and in a straight line to minimize the potential for “hang-up” as the tubing is pulled through. See figures 4 and 5.

Figure 4: Feeding the tubing into the existing pipe

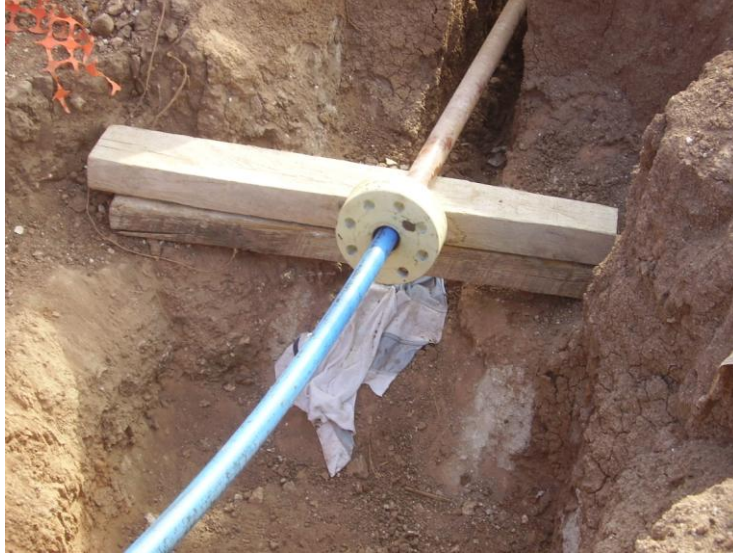
Figure 5: Pulling straight into the Existing Pipe
