January 2009

Rehabilitation of Existing Platform to Platform Pipeline Crescent Petroleum

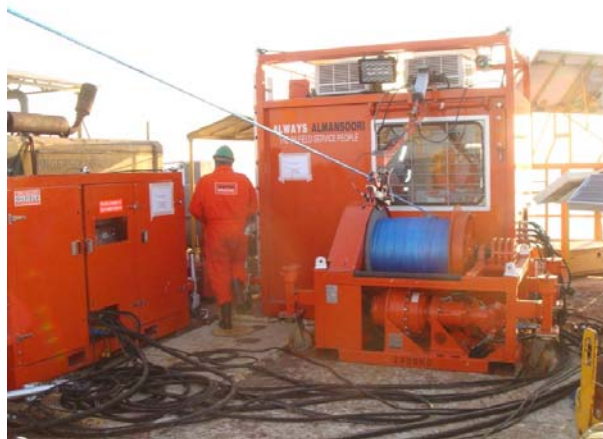
Figure 1: Pulling Rope and Winch

The existing high pressure steel pipe was pigged to assure that there were no restrictions along the line. A braided rope wound on a winch was then attached to a pig and pulled through the existing pipeline. The rope was rated for 34,000lbs breaking strength. See figure one.

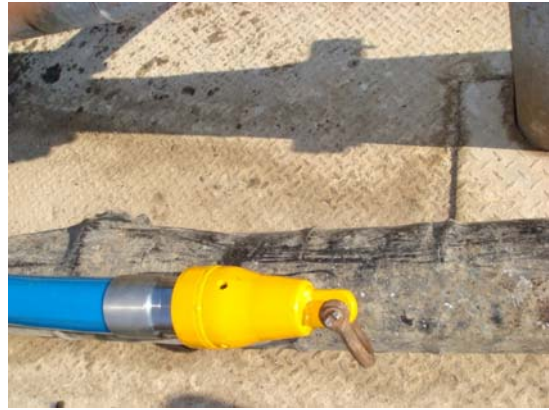
Figure 3: Pulling Cone

Once the roped is pigged through the existing pipeline, the spools of pipe (see figure 2) were set into position, a termination coupling was installed on the end of the pipe and a pulling cone screwed on to the termination coupling for pulling (See figure 3)

The pulling cone was attached to the rope and the winch pulled the pipe off an A-frame at a rate of 10 to 20 feet per minute (3 to 6 meters per minute) The maximum length of tubing that could fit on a 10ft spool is 1,800ft. When one spool was complete, the pulling was stopped, a splice coupling installed to connect the next spool. (See figure 4) There was radio contact between platforms to make sure the winch operator knew when to stop and start the pulling and to make sure the load did not exceed 9,000lbs of tensile load. Thermoflex tubing can be designed with various pull strength requirements depending upon the pull length and bends in the line. Please consult Polyflow to review the project to determine the correct pull force requirements.

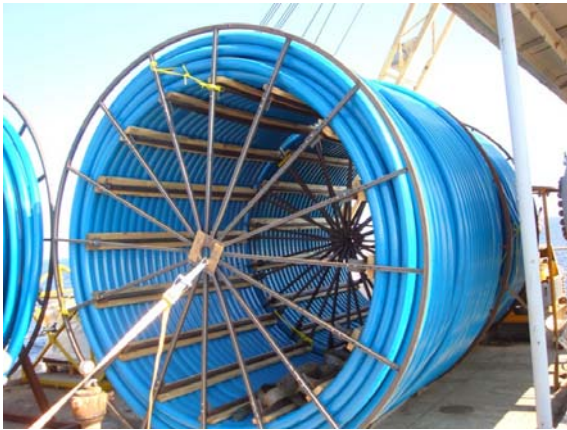
Figure 2: Spools Staged for Installation

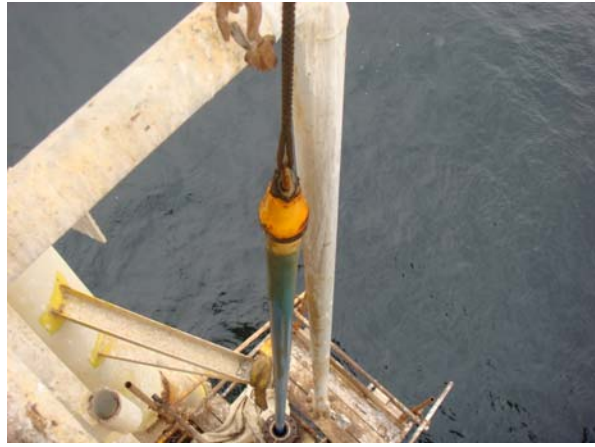
Figure 5: Tubing coming through the riser

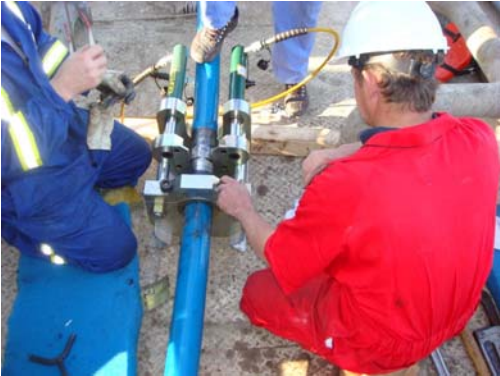
Figure 4: Splicing Tubing Together

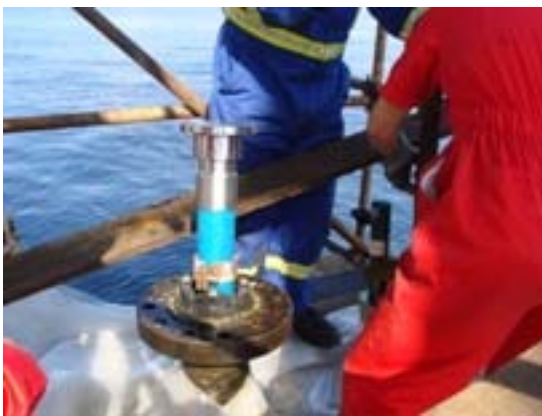
Figure 6: Flange Termination

Once the entire tubing length was pulled through the existing pipe, a flange termination was coupled on the tubing and the line was pressure tested at 1,700PSI with water. The line was then pigged of water and put into service. The entire project took three and a half days.
