Thermoflex[®] Oil Gathering Line Installation Case Study

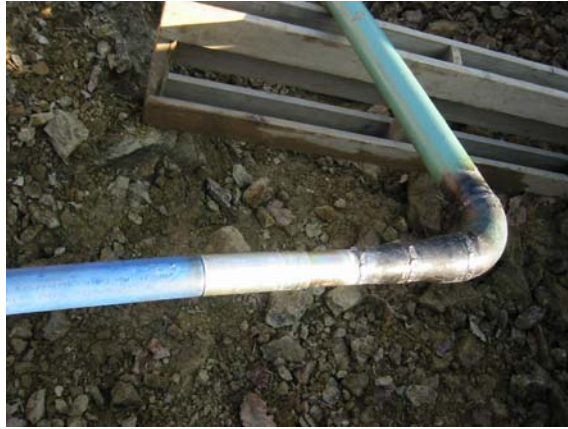
Welded Tubing to Steel Riser

The pipe was set up on a spooler and was set up near the termination of the first line. The pipe was pulled off the spool by hand and with a bulldozer for approximately 1,200 ft. The couplings were installed and then welded to steel risers. Per the instruction manual, care was taken in welding the couplings to the risers by putting a heat sink (wet towel) on the coupling to keep the temperature at the ferrule below 250F. The tubing was dropped into the hole, pressure tested then backfilled all the same day.

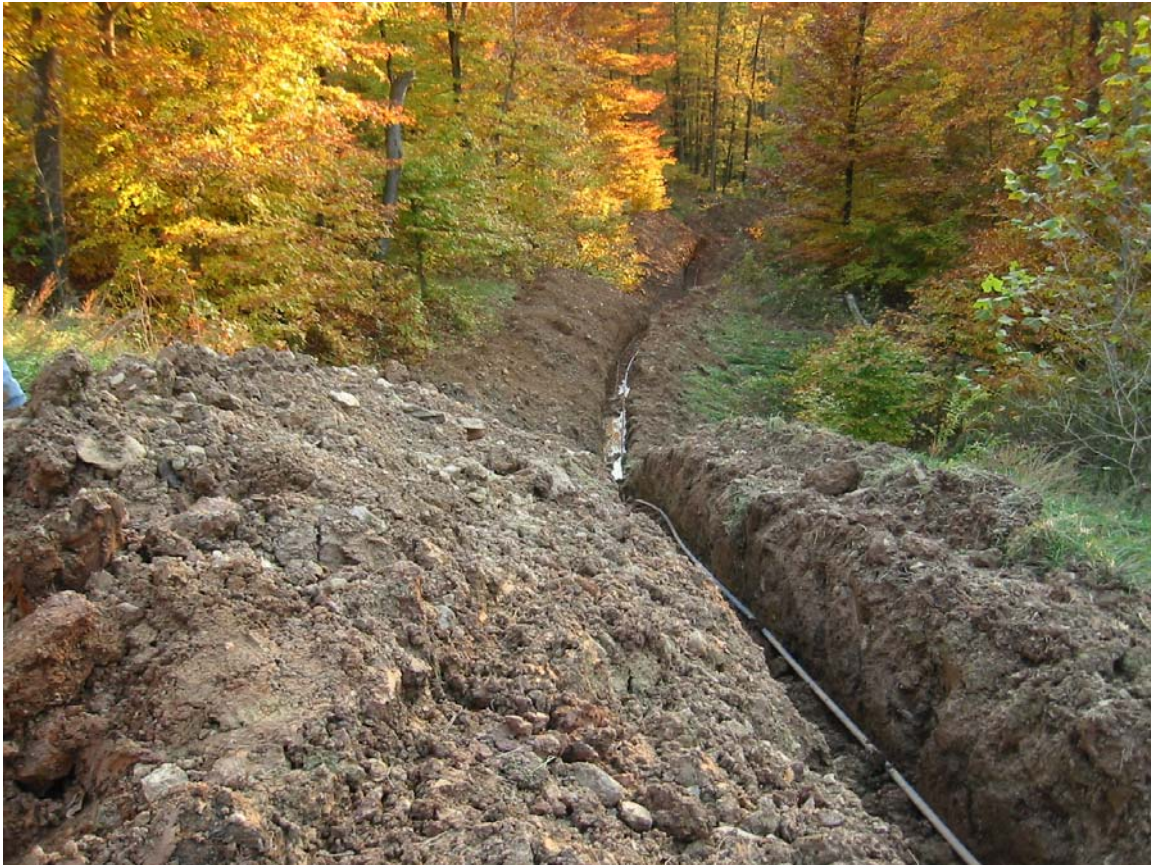
Tubing immediately after pull

The second line had a much more severe terrain. After slow trenching the first 2,200ft line was pulled in about an hour. This was done by hand and pulled with a rope in the steep areas.

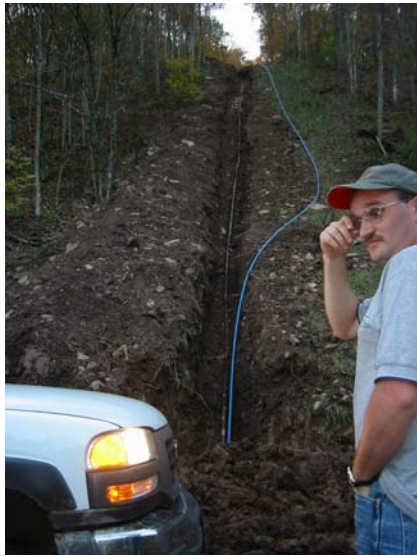
Steepest Section
